TITLE: Integration of Measurements and Maneuvering Technologies Used to Modify Caisson

Integration of Measurements and Maneuvering Technologies Used to Modify Caisson

No. 2A-2

Joseph Krulikowski, Member, Peter Sparacino, Visitor, and
Anthony Giordano, Visitor, Philadelphia Naval Shipyard

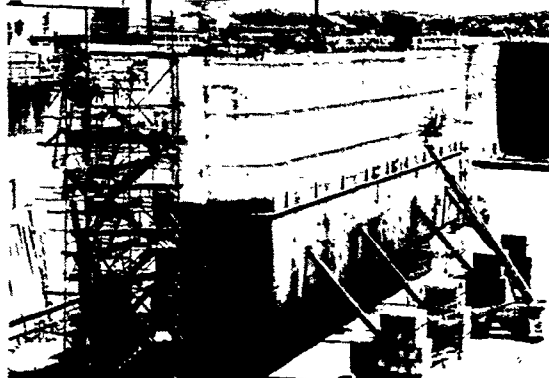
Figure 1.
New York Shipbuilding Corp. Caisson

A new caisson was estimated to cost over 4 million dollars, which exceeded the repair budget. Fortunately there was a large caisson on the base which was built by the now defunct, New York Shipbuilding Corporation (NYSC) Figure (1). It had been in service in Camden, New Jersey, for a special drydock used in the construction of the USS KITTY HAWK (CV63) in the mid 1950's. Because the caisson was stored in fresh water and had only limited use at NYSC, it was in virtually new condition. The overall dimensions of the caisson, with the exception of the length (8.38 m, 27.5 ft longer) were very similar to the original caisson. Its all welded construction made it easy to modify.

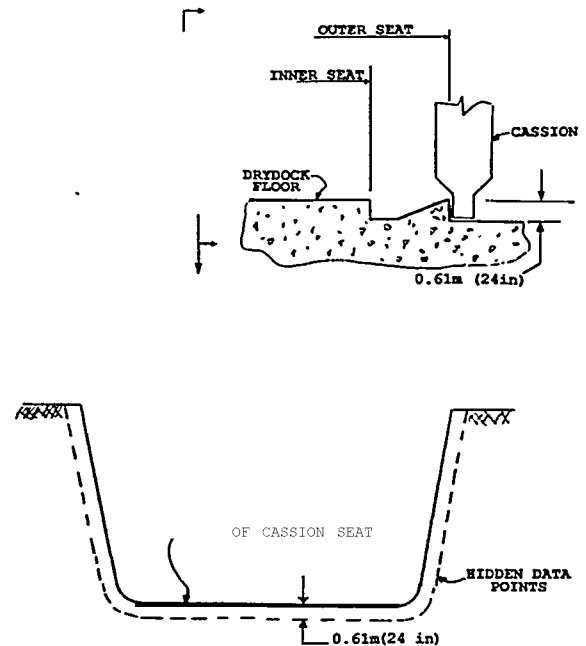
Figure 2.
Drydock NO.3 Opening

The first task for the measurement group was to provide data of the existing drydock opening (figure 2). Determination of theodolite positioning was the first concern. Placing the instruments between the inner and outer seat was eliminated for two reasons. First, a limited sight distance and very poor geometry between the theodolites and the data points impeded the accuracy. Second, with the existing caisson continuously leaking and the readings taken in the winter months, very hazardous safety conditions existed in this area with partial freezing of standing water. It was then determined that the theodolites would have to be located on the drydock floor. This created a situation where most of the data points would be hidden from sight (figure 2).

Hidden points were captured using a hidden point stick which is a targeted measured rod. By sighting the targets of the rod the theodolite system can automatically interpolate for the hidden point using the software (hidden point routine) provided with the system. Data for the drydock seat area were taken at various stations with two points per station. One representing the upper edge of the seat, which was visible and the other representing the bottom corner which was hidden. Points were taken at four stations along each side. Also,

points were taken at 15 stations in the radius area, because it was critical for fit.

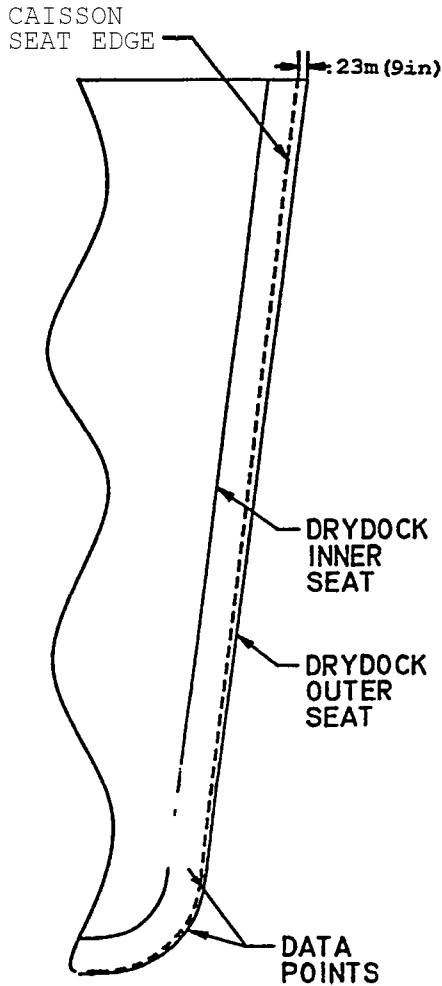
FIGURE 3.

CAD OVERLAY OF THEODOLITE DATA

Data taken from the survey was transferred (using a 5 1/4" floppy disc) directly into the shipyard CAD system. This allowed viewing all the data taken in three dimensions. By using curve fitting techniques, an accurate picture of the seat of the caisson and the drydock opening could be obtained. Figure 3 shows a CAD overlay of some measurement data taken.

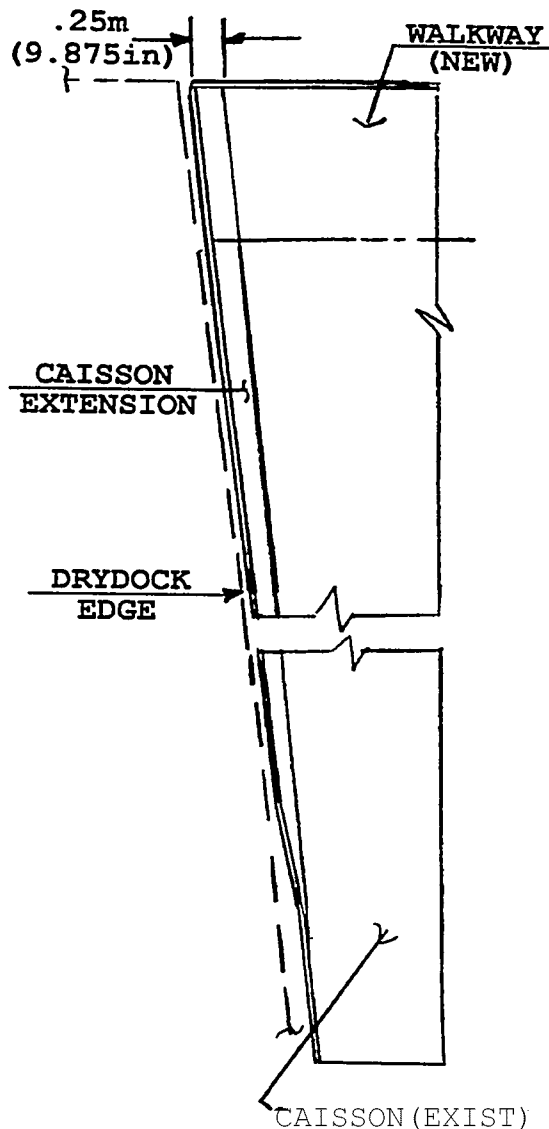
Figure 4.
Caisson Final Dimensions

Several different scenarios were evaluated. The most cost effective one was to modify the caisson asymmetrically by adding structure to one side only. This would make the clearance different at the ends if the caisson were positioned at the centerline of the drydock. But the clearance would still be within allowable tolerances if the caisson were shifted to one side or rotated 180 degrees. By jogging the seal about 6.1 meters (20 feet) from the base and removing 8.38 m (27.5 ft) from the center of the caisson we were able to meet all dimensional clearance criteria. Final dimensions are shown in Figure 4.

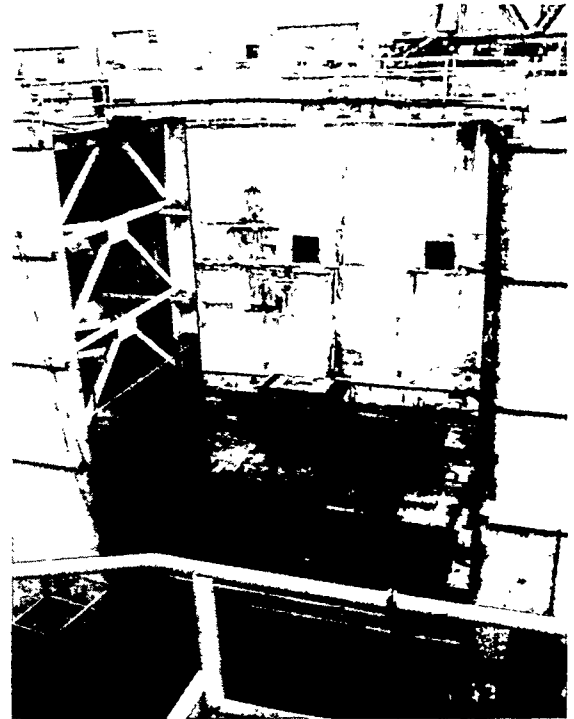
Figure 5.
Steel Removal, Center Section

The area of steel removed was about 8.38 m (27.5 feet) long, 10.67 m (35 feet) high and 6.1 m (20 feet) wide across the top.

between the two halves of the caisson. Shipfitters and welders worked to remove the large portions of plating and beams from the center section (Figure 5).

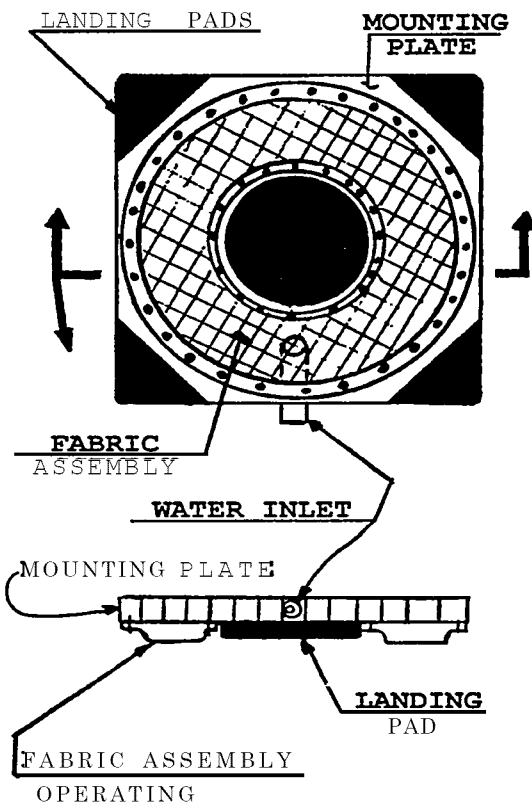
The castors operate on a water film created under the castor by water leaking from the bottom of a diaphragm (Figure 10).

This allows the entire castor/caisson to "float" just like a glass filled with fluid on a wet smooth surface. The castors are flexible, so they could accommodate the lack of flatness of the

Figure 10.
Water Film Castor

drydock floor. Also, because of their flexibility the load per castor would remain fairly constant during the move, allowing the supporting steel fixture to be optimised around well defined factors of safety. Steel plates welded together were placed along the drydock floor to prevent loss of water due to small irregularities such as holes in the concrete surface. The castors moved with the caisson along the steel plate track due to the differences in friction between the temporary support surface and the steel path surface. The castors used during the move required about 0.483N/mm^2 (70 PSI) of water pressure at each of the castors in order to obtain 0.08 m (3 inches) of lift off the keel blocks. Production shops manufactured two separate manifolds with ten gauges, each dedicated to one castor for monitoring purposes.

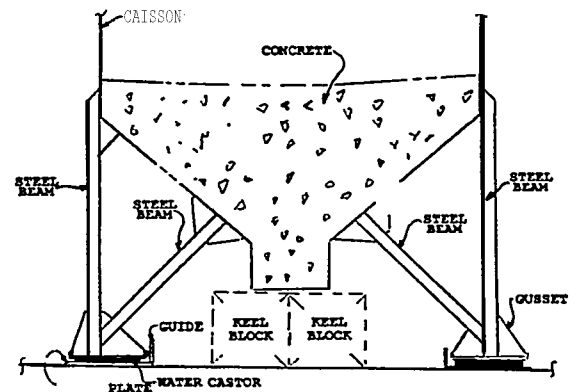
The castors were rented with a representative from the vendor providing technical characteristics such as load capacity, friction factors, surface slope, and water supply. Using this information, temporary supports made of steel I beams and plates were designed. Each support was fabricated out of three I beams spaced like a tripod, over each castor to handle any rotations (Figure 11).

Figure 11.
Temporary Supports For Floating Half of Caisson

In this way the lifting force at the center of pressure of the castor, would remain stable in the area defined by the supporting legs. Calculations showed that a total of 20 castors would be required providing a capacity of 725,750 kilograms (1.6 million pounds). The section to be moved was 589,670 kilograms (1.3 million pounds) and the center of gravity was calculated to be 3.05 m (10 feet) up from the bottom. The castor model chosen was by AERO-GO and its designation was 4K48HDL. It was 1.22 m (4 feet) by 1.22 m (4 feet) by 0.07 m (2.75 inches) thick with a lift of 0.08 m (3.0 inches). The castors were placed between the temporary
